SAFETY ALERT

Alert: Electrical Fire Risk - Safety Alert 027
Subject: Electrical Appliances / Laptop
Chargers

Reference Number: Safety Alert 027

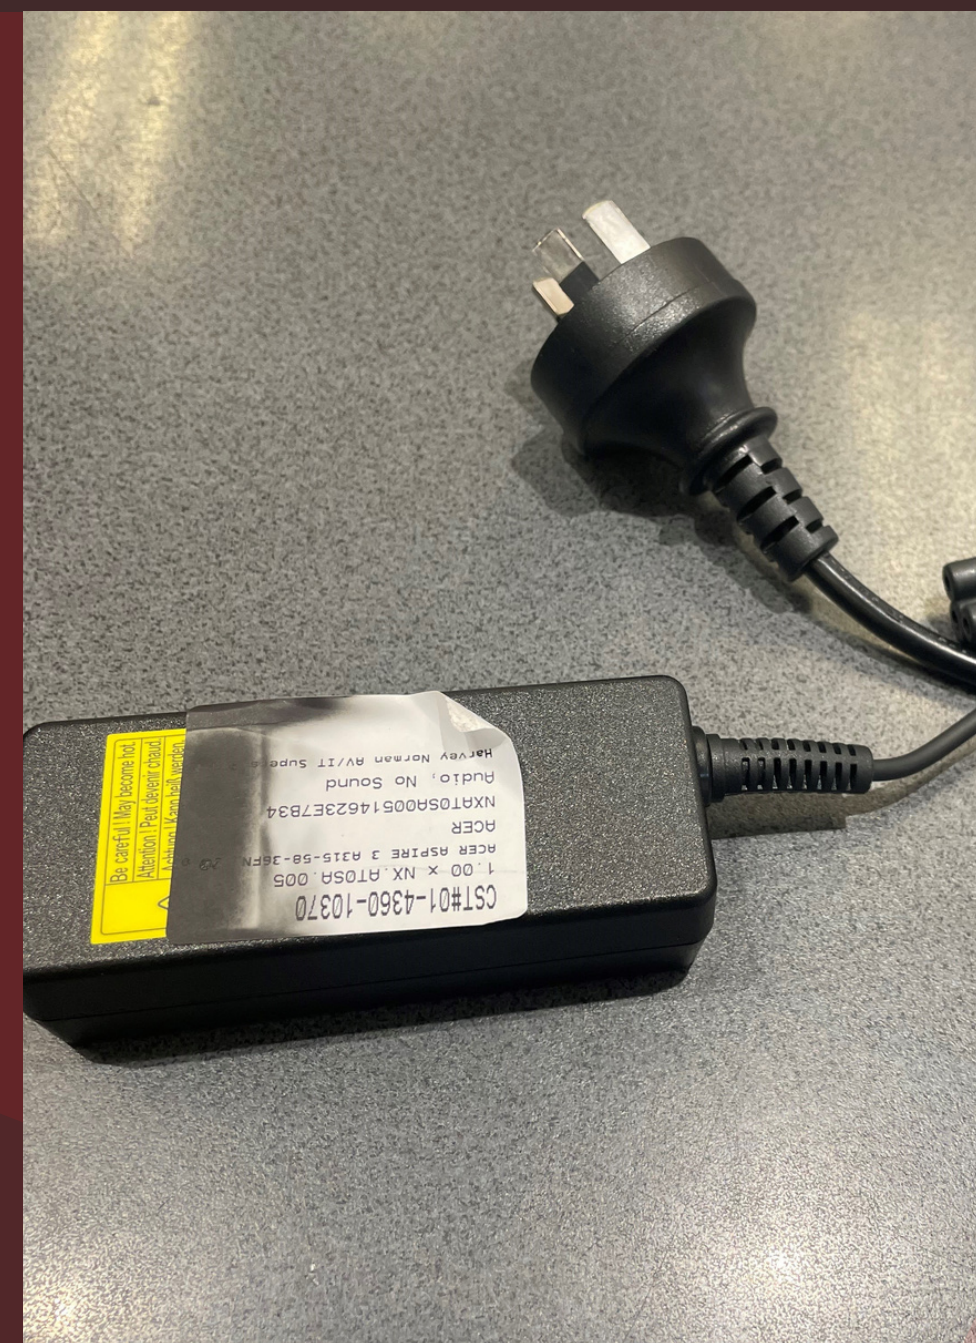
While working at home, laptop was charging for approximately 10 minutes when a popping sound was made, and blue sparks observed coming from a brand-new laptop charger. As the room quickly filled up with smoke and the potential risk of fire e.g., unseen in the walls or power point, the house was evacuated, and the Fire & Rescue called.

Following an internal investigation and inspection of the unit by two competent persons, there was no evidence of reverse polarity - simply a faulty charger

The worker unplugged the device and then immediately contacted 000. Power to the house was also isolated.

The wall and power point were tested with thermal scanner to verify there was risk of further fire. Power was not turned back on until an electrician confirmed there was no unseen damage.
